HOBE-ST. LUCIE CONSERVANCEY DISTRICT

2015 Facility Evaluation Report – Phase I

Prepared by:
Higgins Engineering, Inc.

July 24, 2015

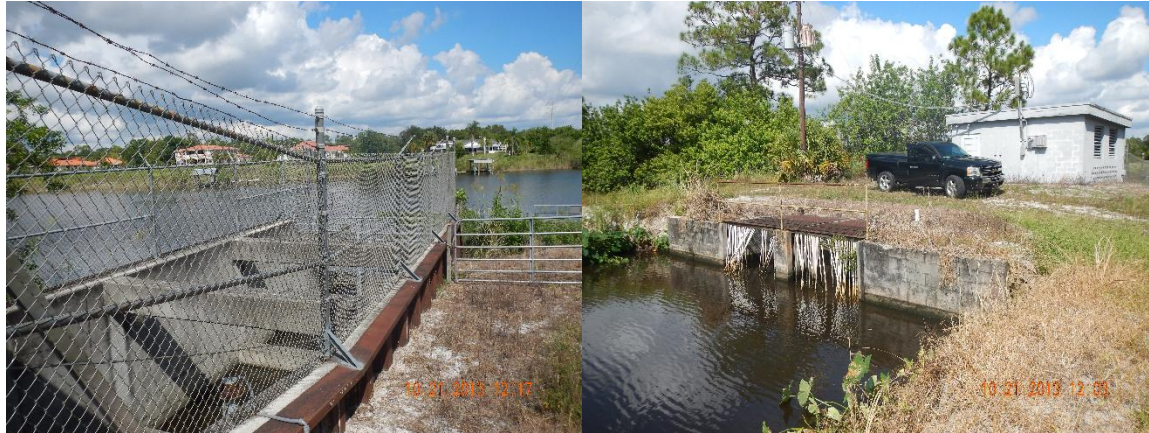
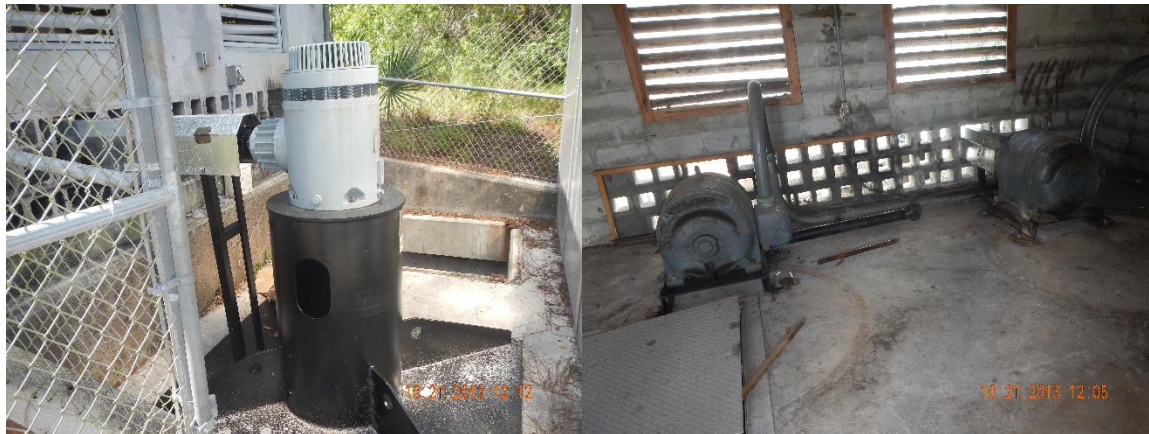
St. Lucie Irrigation Pump Station

The pump house, a concrete block building with a removable roof, appears to be in good condition. The entire facility is enclosed in a 6 foot chain link fence which is also in good condition with the exception of the corrosion where it comes into contact with the concrete. Additional supports have been welded on to the fence to provide structural strength. In the future the fence posts will likely need replacement. It is recommended the posts be properly treated anywhere they come in contact with concrete. The only areas that

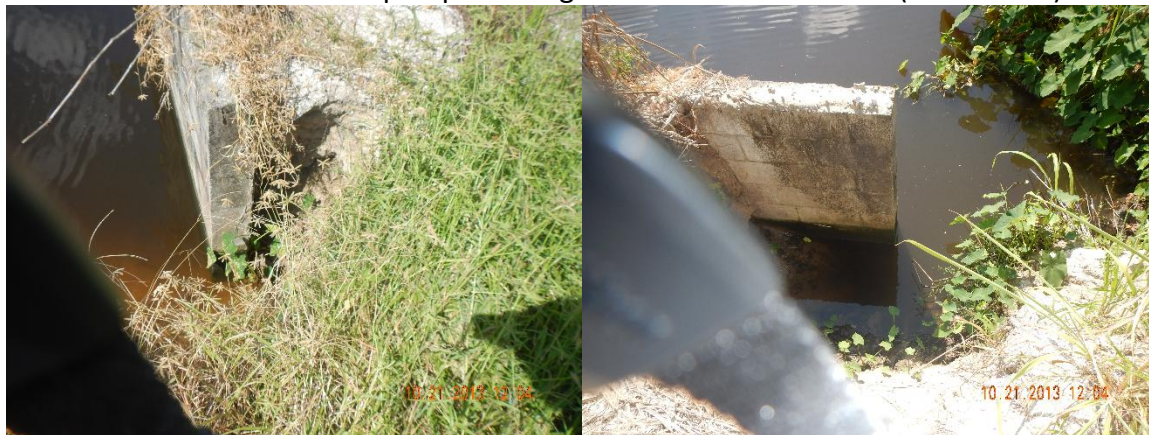
Erosion around headwalls of pump discharge needs to be addressed (Short Term).

1. Address the erosion around the St. Lucie Irrigation Pump Station outfall before damage is done to the infrastructure.
2. Address the leak at the Unit Number 3 Outfall Structure.
3. Continue an aggressive aquatic weed control program. St. Lucie Canal to Unit 2 (IC 2)

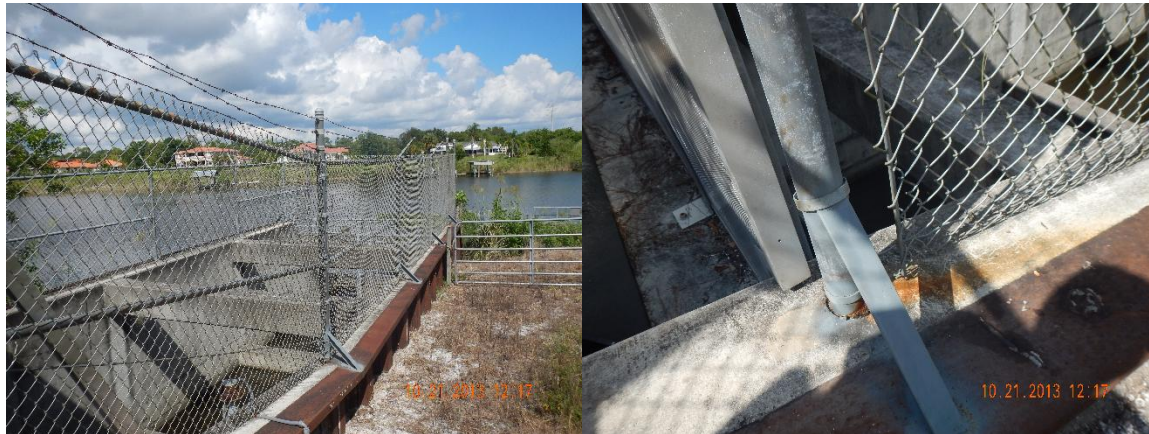
The fencing around the intake structure which was contacting the cement corroded near the contact point. A short term repair has been made by welding braces to the fencing. At this

time the repair is holding up fine, but should be watched for additional corrosion. Fencing should be budgeted for replacement (Mid to Long Term).

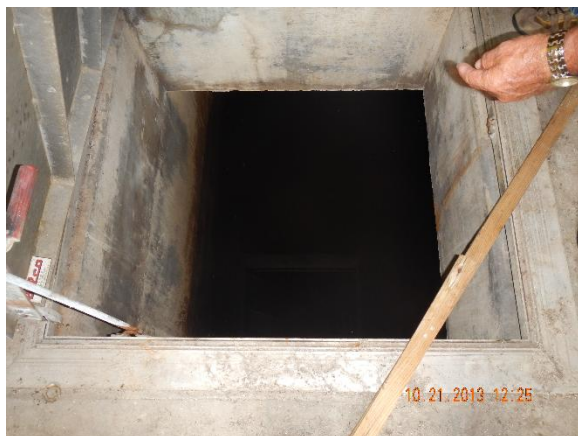
Flap gates in stilling well were replaced this year. A grease fitting was installed that will allow for the flap gates to be greased from the stilling well opening. Before greasing, the flap gate hinges required a maintenance person to go into the stilling well which is time consuming and challenging.

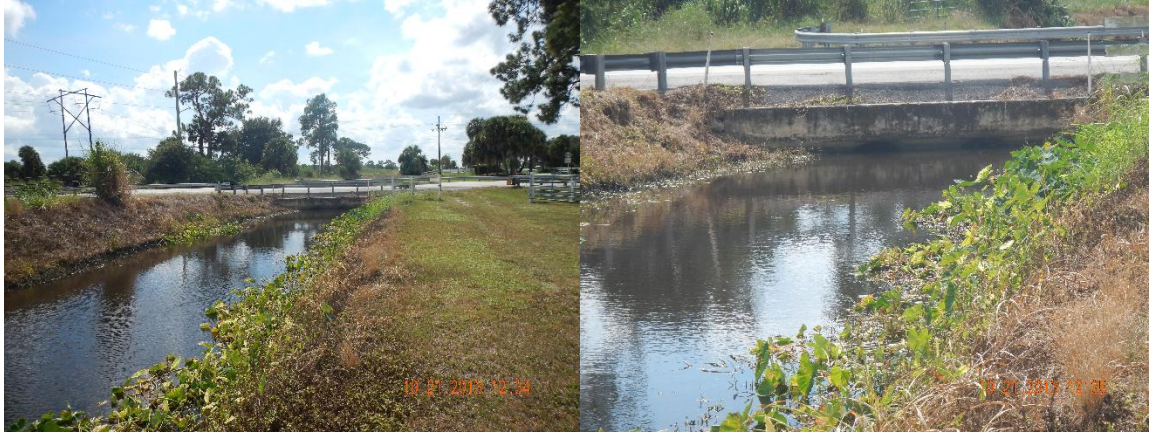
During a freeze that occurred in the past both pumps were running and water reportedly was observed flowing over the road. With the refurbishment of the pumps it can be expected that the pumps will be pumping closer to their design flow rates. A HEC-RAS and S2DMM analysis was performed which showed the two 42" Culverts and the Irrigation Canal (IC-2) are capable of providing conveyance for both pumps turned on. Regular maintenance is required.

The channel itself is in relatively good condition, and while some nuisance species were observed, it does not appear to impede the flow of the channel. The entire Channel recently was mechanically cleaned. Regular maintenance is required.

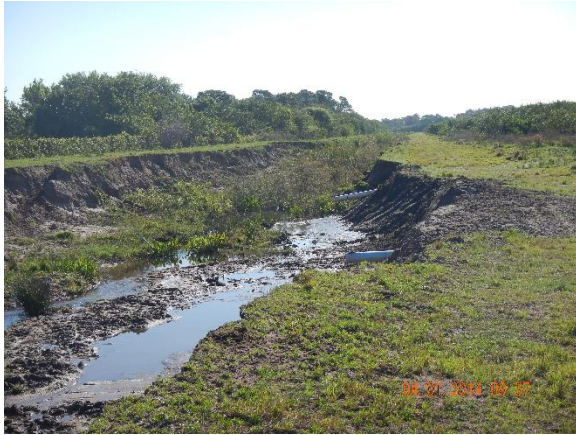
Most of the internal canals in Unit 1 have been filled in and conveyance of storm water is a problem in heavy rains. The remaining internal canals in Unit 1 have serious canal bank erosion as a result of the cattle tearing up the banks to get down to water and then back out again.

Erosion from cattle

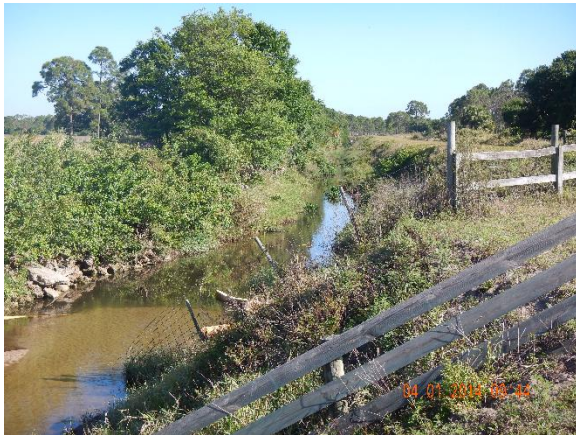
The south and west banks of the OC-1 outfall canal are heavily overgrown with vegetation encroaching into the canal itself. The canal must be maintained from the north and east banks using a long stick back hoe, which is more expensive to operate.

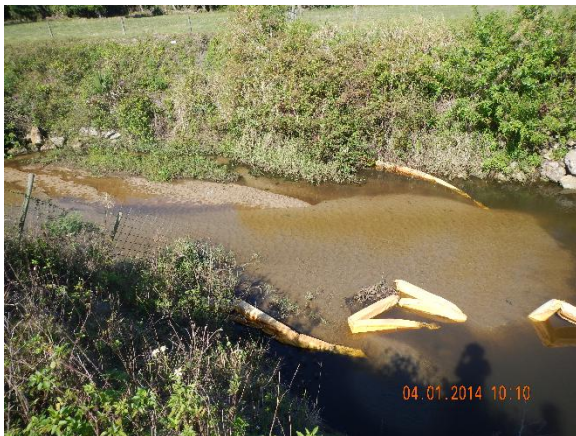
Just upstream of the outfall culvert there is an erosion problem and an old turbidity barrier that needs to be addressed.

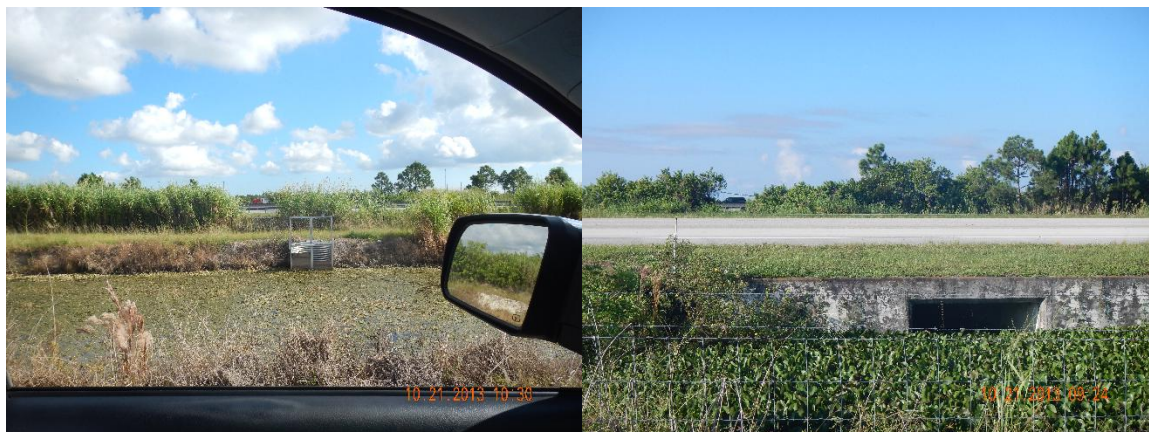
Aquatic vegetation on both sides of the culvert could be cleared if conveyance presents a problem. At this same location two culverts with risers have been replaced for the Turnpike Canal to provide irrigation to the South.

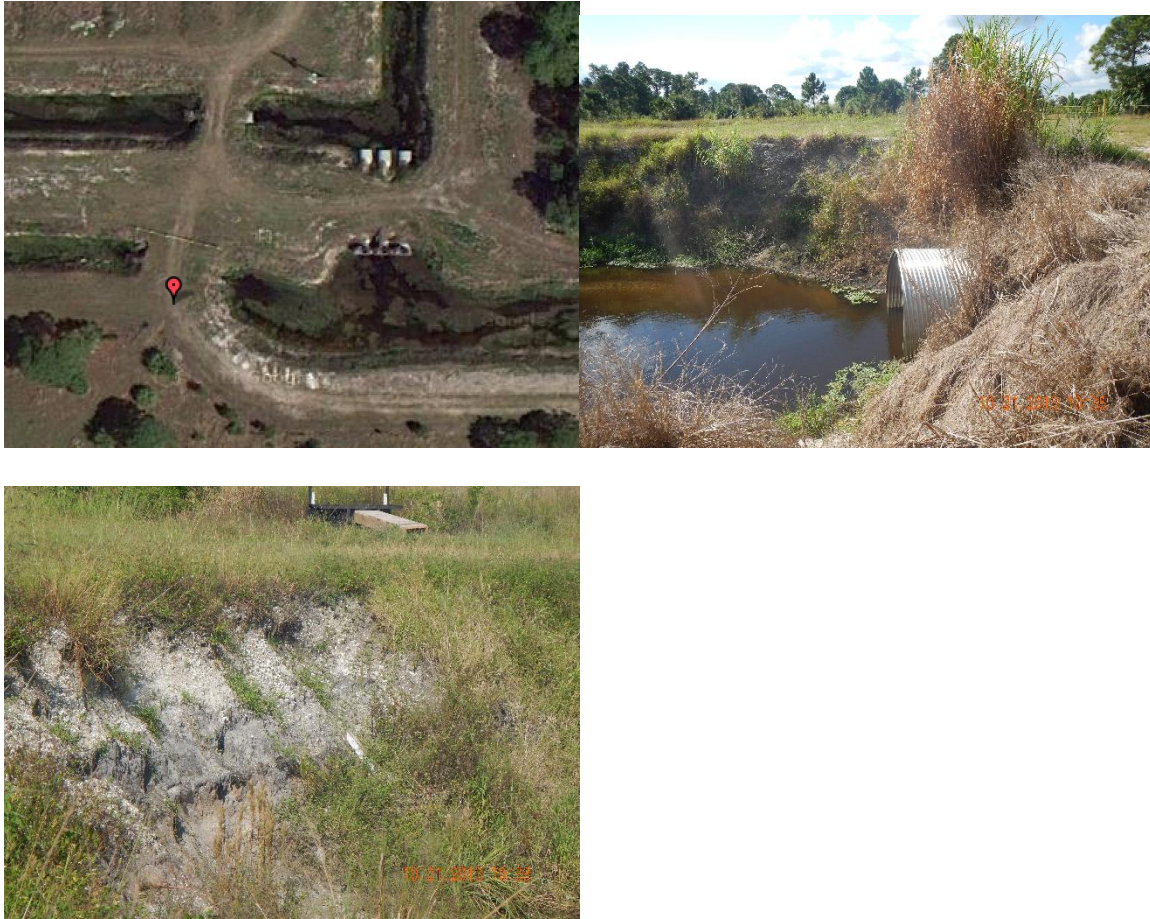
The three 84" culverts in the pictures which head south were replaced in January. The flash board risers were moved to the north side of the structure. Some erosion on the banks is evident and should be repaired.

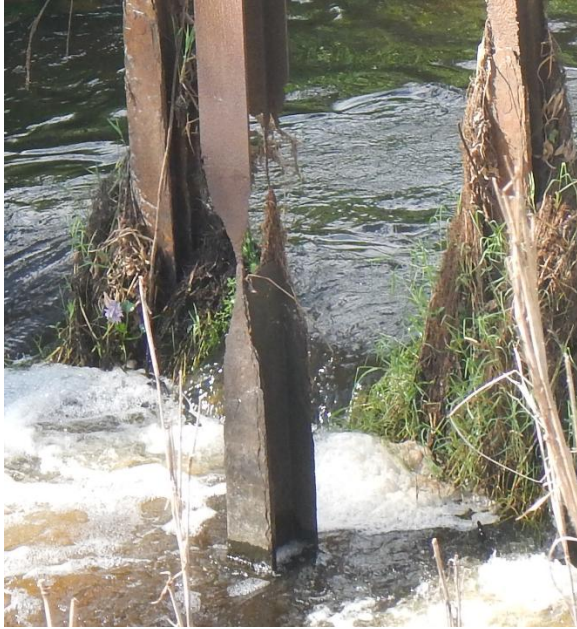
The Cypress Creek outfall structure was in poor condition and in need of replacement or repair. The structure was supported, in part by steel uprights that were severely corroded with portions of the supports corroded through. In addition, these supports acted to catch floating debris as waters discharge through the structure, causing a blockage and additional stress on the structure. Because this structure and aquatic plant debris posed a significant concern to the functioning of the outfall facility, the supports and catwalk were removed.

Structural components rusted through
Discharge

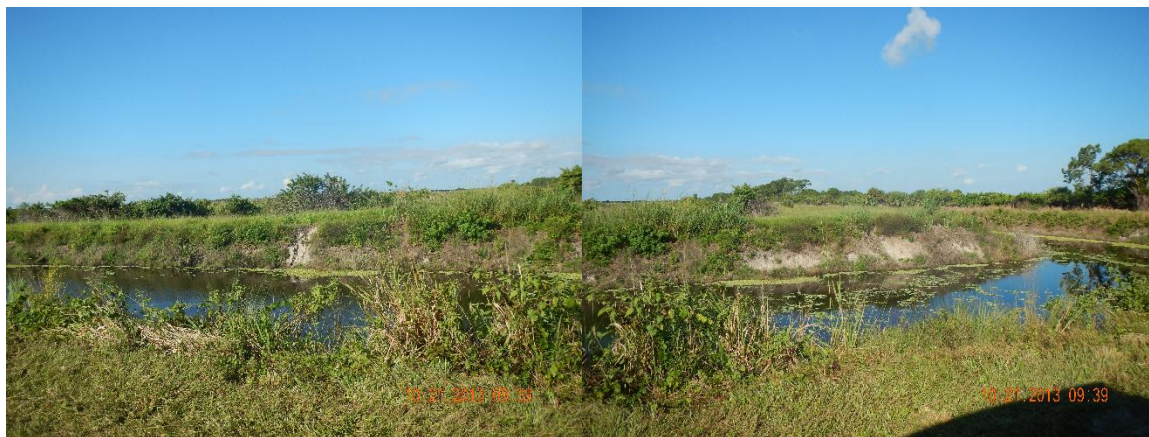
The Unit 3 outfall, commencing at the southeast corner of Unit 3, is in fair to good condition with aquatic weeds matting in isolated locations without currently impacting flows. However aggressive maintenance treatment on all canals shall remain a continuing issue.

Canal bank erosion

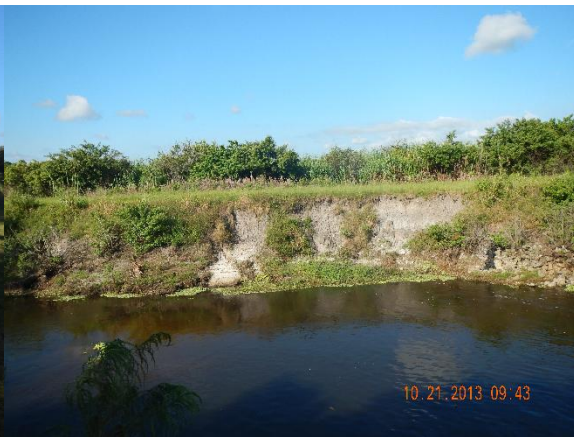
The outfall structure was constructed in 1993 and appears to be in good condition however, it was observed that some wash outs along the edge of the structure are occurring. These wash outs should be repaired as soon as possible and additional erosion protection measures implemented to protect the structure from further erosion. Also cap repair is needed where the structure is leaking.

Downstream Bank Erosion

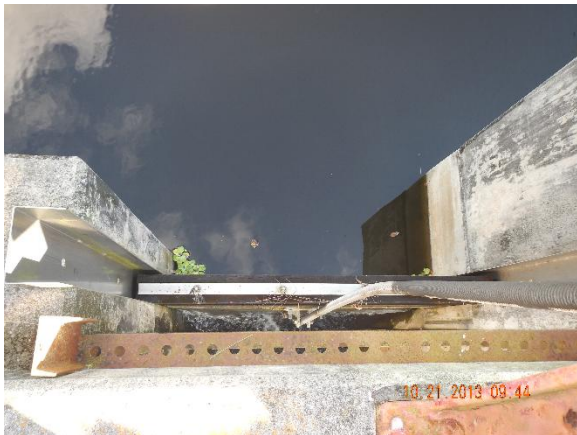
The spindles for the gates will also need to be replaced as they are bent and out of alignment. This likely occurred as a result of over tightening the gates, causing the aluminum spindles to bend. As a result, any effort to replace these spindles should also include installation of a lock nut, to prevent them from being damaged in the future.

Bent Stem

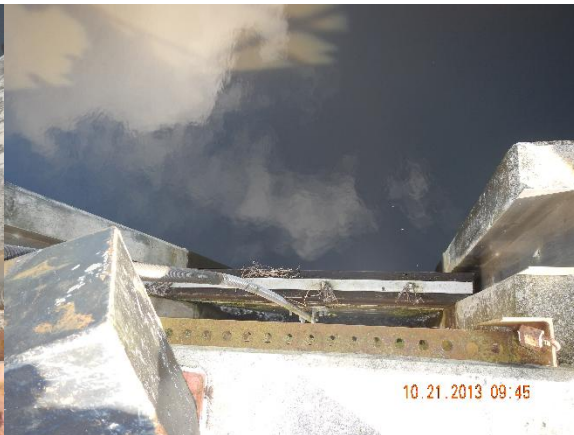
Bent Stem

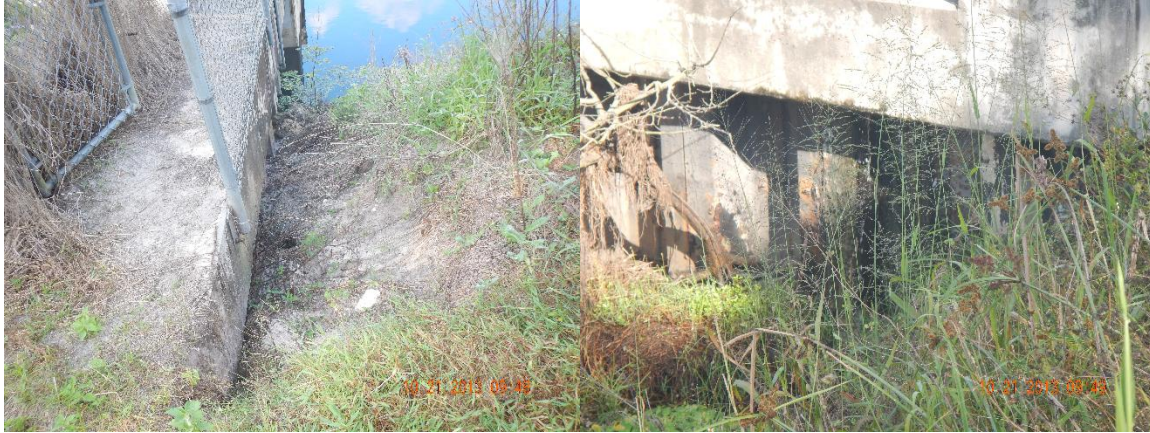
Erosion upstream of Structure
sheetpile

leakage under concrete cap/corrodged

1. Address the erosion around the St. Lucie Irrigation Pump Station outfall before damage is done to the infrastructure.
2. Address the leak at the Unit Number 3 Outfall Structure.
3. Repair, replace or remove the Unit Number 2 Outfall Structure.
4. Continue an aggressive aquatic weed control program. St. Lucie Canal to Unit 2 (IC-2)
