HOBE-ST. LUCIE CONSERVANCEY DISTRICT

2015 Facility Evaluation Report – Phase I

Prepared by:
Higgins Engineering, Inc.

July 24, 2015

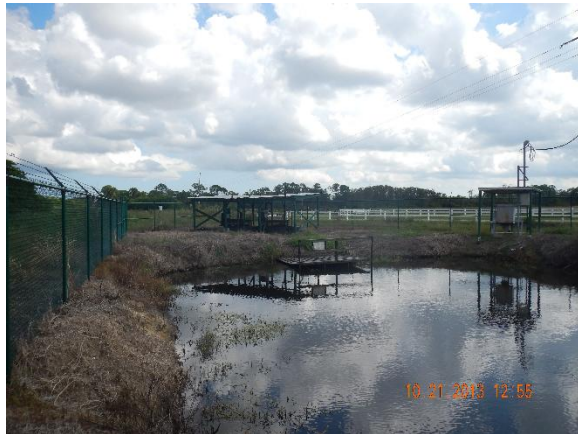
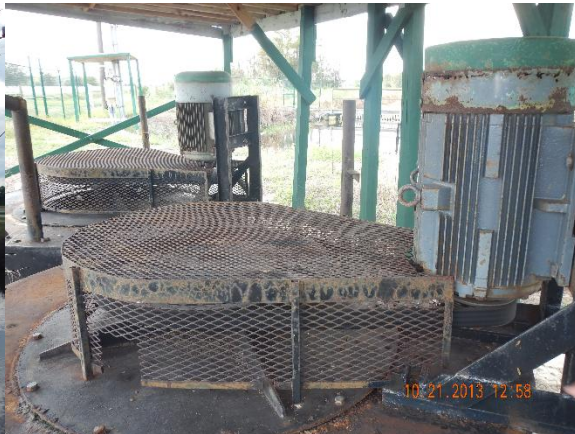
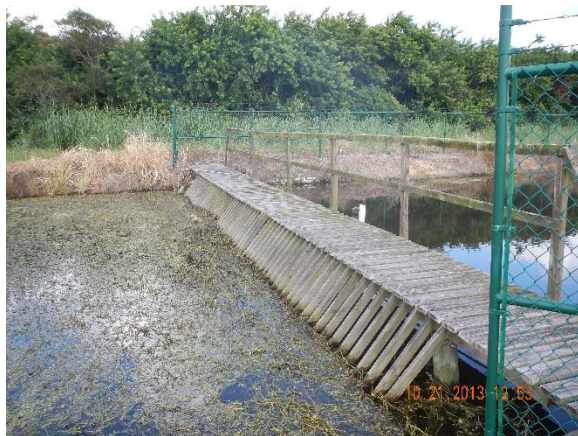
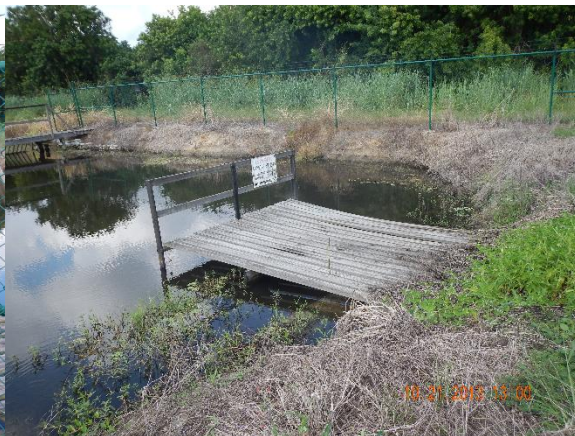
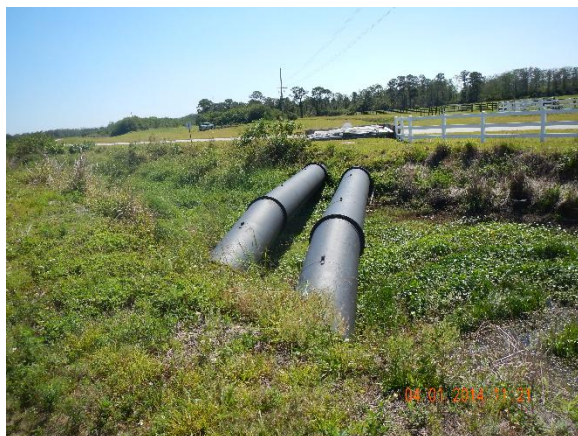
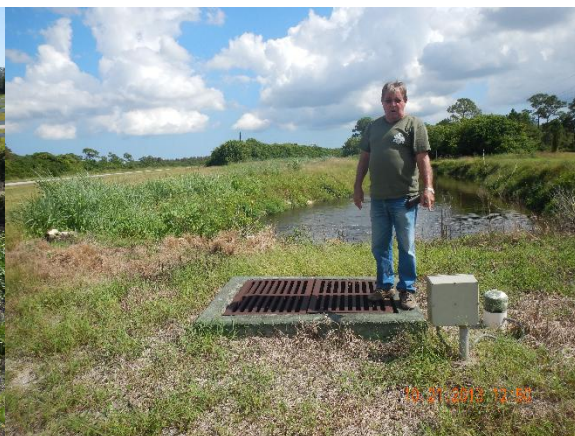
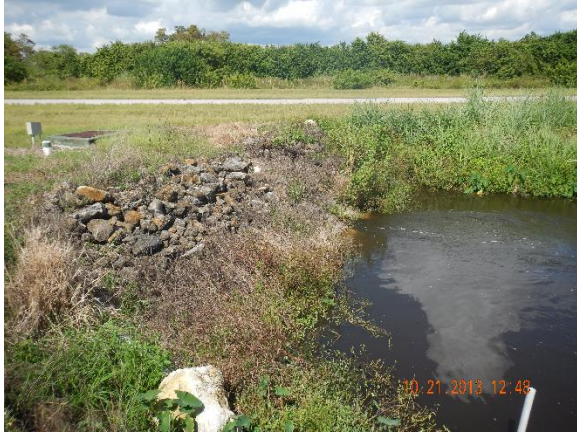
Both Pasture Pumps were refurbished earlier this year. This pumping station is protected on the west from floating debris by a wood grate and dock. The dock and grate system are wood and are in good condition.

The intakes to the pump wells, originally installed in the 1960’s, are also in need of repair and possibly may need to be replaced. As they were submerged it was not possible to inspect them directly.

The North motor is relatively new approximately (11 years old), however the south motor is estimated at approximately 35 years. While the south motor has been rewound twice over the past 35 years, its open design makes it prone to damage from the elements. For these reasons it is recommended the District budget for replacement of this motor within the next 10 years.

The District has constructed a secure fence enclosure to protect the pumps and intake fore-bay. The Gate while locked was easily opened with a tug. It is recommended the fence gate posts be reinforced with additional concrete anchoring to make the lock effective or use a chain around fence posts to lock the fence.

The outfall, a single 48 inch culvert is in good condition.

Recommend a chain around the gate near the weed barrier to securely lock the gate.

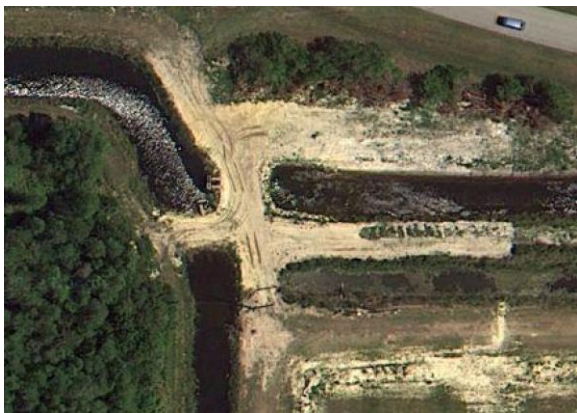
Irrigation Culverts (aerial view)

Downstream of the Pasture Pump Station are three CMP risers, one of which diverts flow to the Thomas Produce fields to the south, while the other two maintain flows to an access point for Unit 2 to the East. These were recently replaced within the last year.

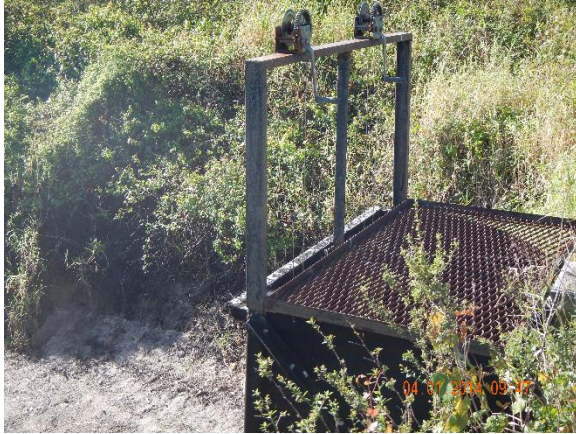
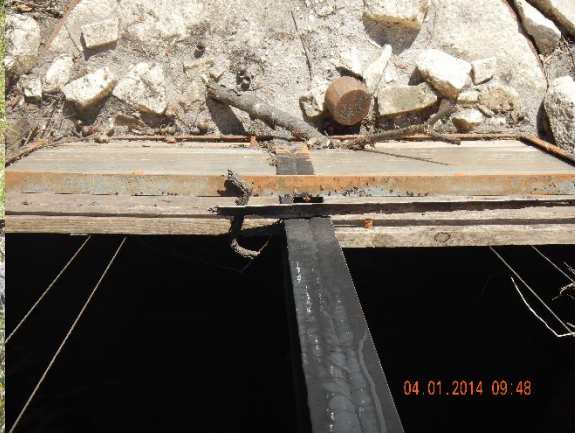
B. The 72" Culvert for water from State Lands

Intake from side

Intake from top

Just upstream of the outfall culvert there is an erosion problem and an old turbidity barrier that needs to be addressed.

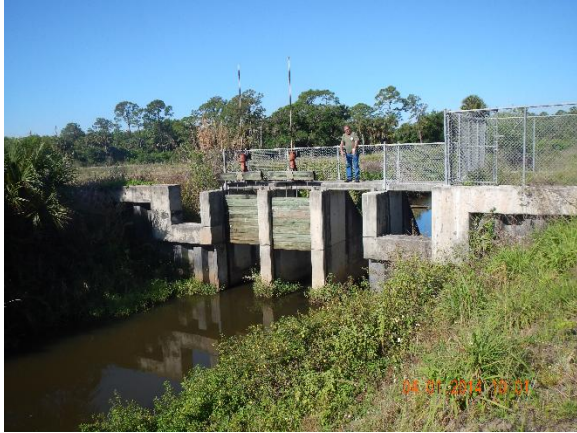
Upstream of Structure

The outfall structure for Unit 1 is of similar design and age as the Unit 3 outfall and in similar condition. The gate spindles were in good condition. The structure was fully open and currently is maintained in this position.

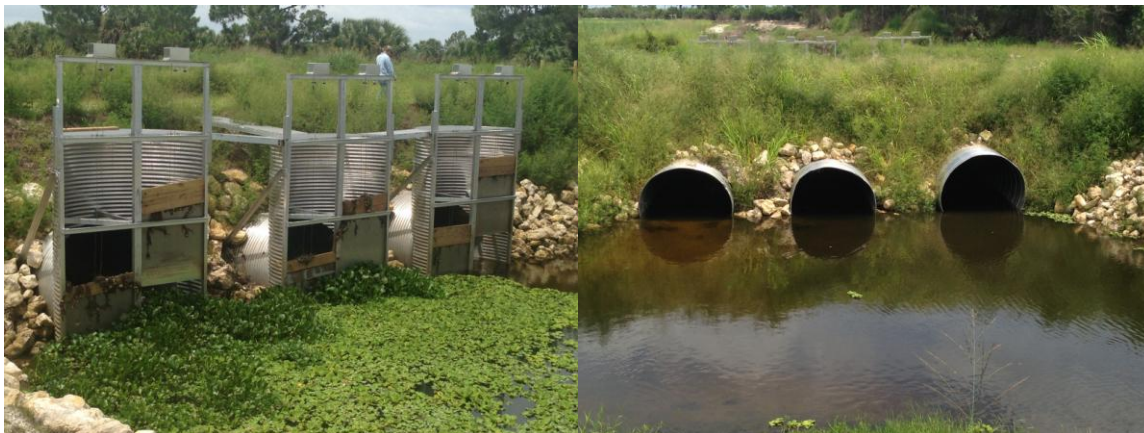
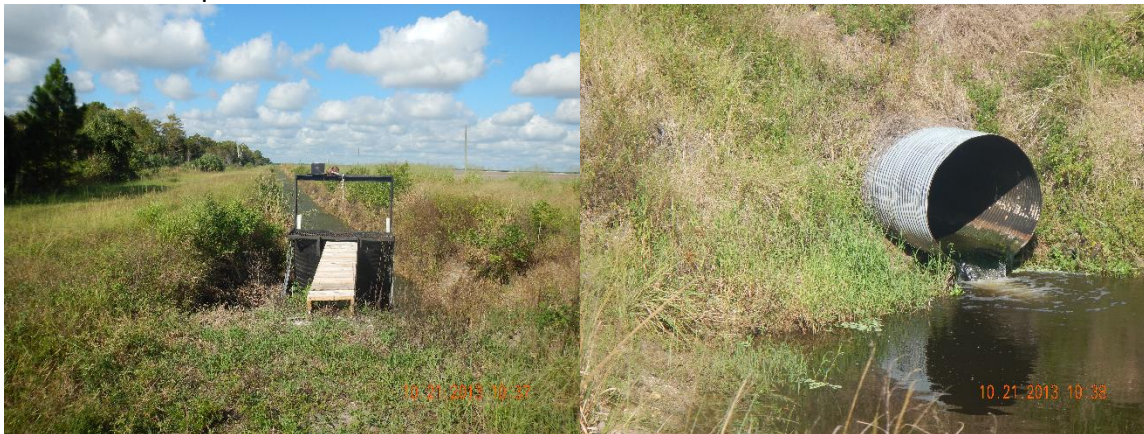
D. Unit Number 2 Outfall Structure

New Culverts upstream

New Culverts Downstream

The three 84" culverts in the pictures which head south were replaced in January. The flash board risers were moved to the north side of the structure. Some erosion on the banks is evident and should be repaired.

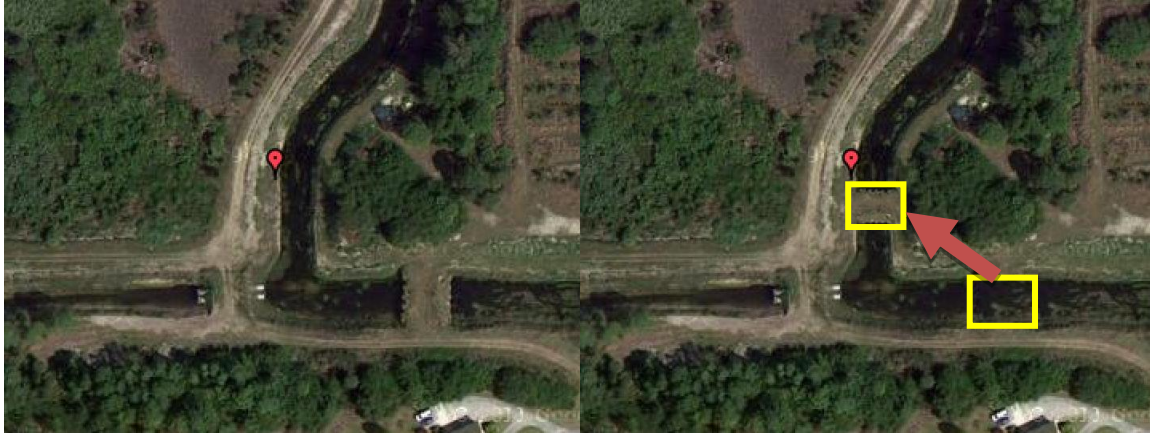
E. New Culvert Crossing SE corner of Balance of the District

Previous Culvert Crossing

New Culvert Crossing

There are currently three crossings over the canal and a catwalk crossing associated with the Cypress Creek structure. This is Crossing Number 1. While preliminary review of District documents indicates that at least two crossings are required as part of prior agreements, their specific location, and need for a third is unclear. Obviously any culvert crossing or restriction in the canal has the potential to plug, and obstruct flows. This crossing (SE corner of Ninejem) was recently replaced with double 96" CAP shown in the pictures.

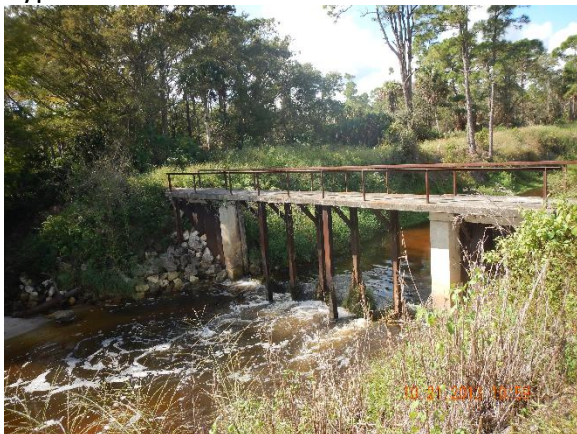
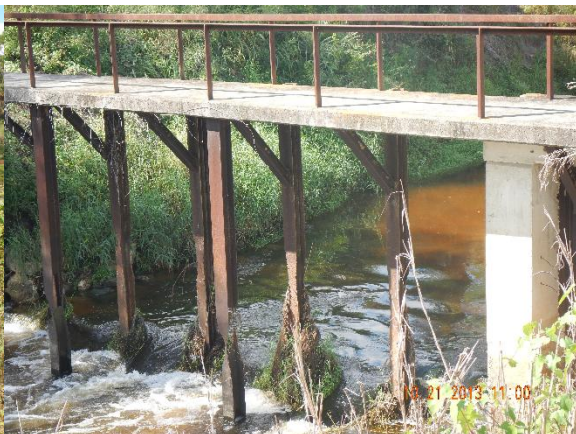
Cypress Creek Structure

The Cypress Creek outfall structure was in poor condition and in need of replacement or repair. The structure was supported, in part by steel uprights that were severely corroded with portions of the supports corroded through. In addition, these supports acted to catch floating debris as waters discharge through the structure, causing a blockage and additional stress on the structure. Because this structure and aquatic plant debris posed a significant concern to the functioning of the outfall facility, the supports and catwalk were removed.

Structural components rusted through
Discharge

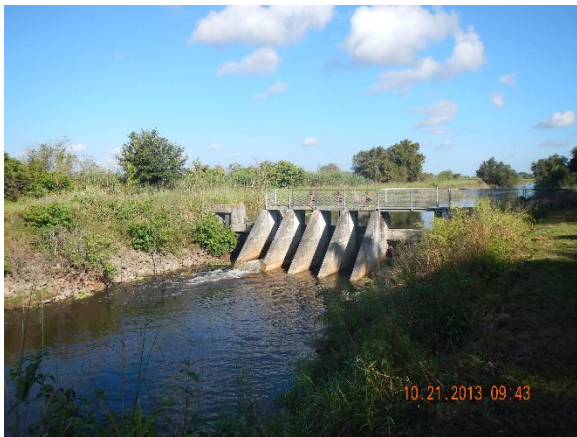
Structure

The outfall structure was constructed in 1993 and appears to be in good condition however, it was observed that some wash outs along the edge of the structure are occurring. These wash outs should be repaired as soon as possible and additional erosion protection measures implemented to protect the structure from further erosion. Also cap repair is needed where the structure is leaking.

The spindles for the gates will also need to be replaced as they are bent and out of alignment. This likely occurred as a result of over tightening the gates, causing the aluminum spindles to bend. As a result, any effort to replace these spindles should also include installation of a lock nut, to prevent them from being damaged in the future.
